U.S. Chemical Safety and Hazard Investigation Board

Hoeganaes Corporation: Gallatin, TN Metal Dust Flash Fires and Hydrogen Explosion

January 31, 2011; March 29, 2011; May 27, 2011

No. 2011-4-I-TN

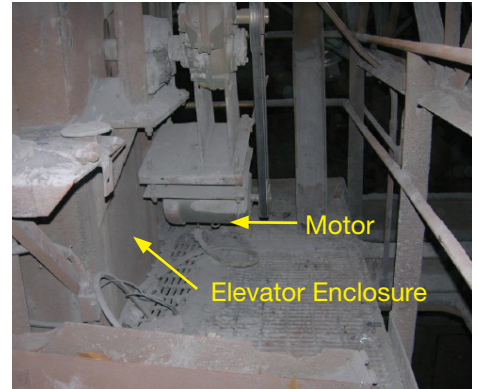
**FIGURE 4 (RIGHT)**

Scene of January 31, 2011, incident area.

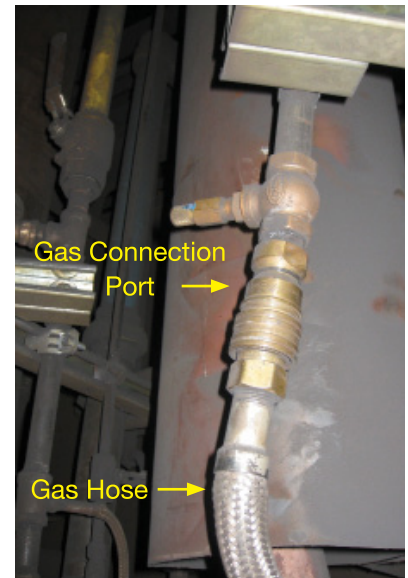
**FIGURE 7 (RIGHT)**

The gas line connection involved in March 29, 2011, incident.

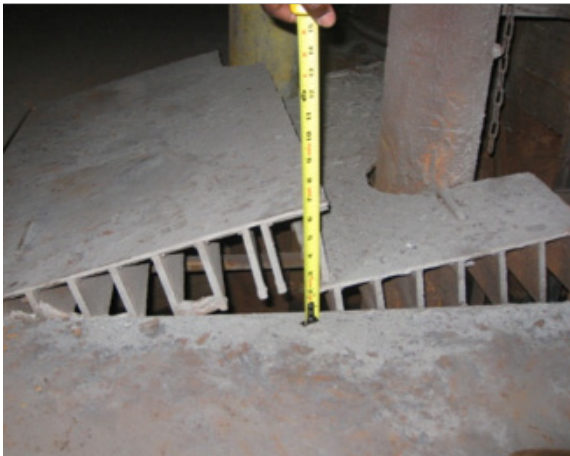
FIGURE 13 (BOTTOM)

Upward disturbance of trench covers caused by the hydrogen explosion in the May 27, 2011, incident.

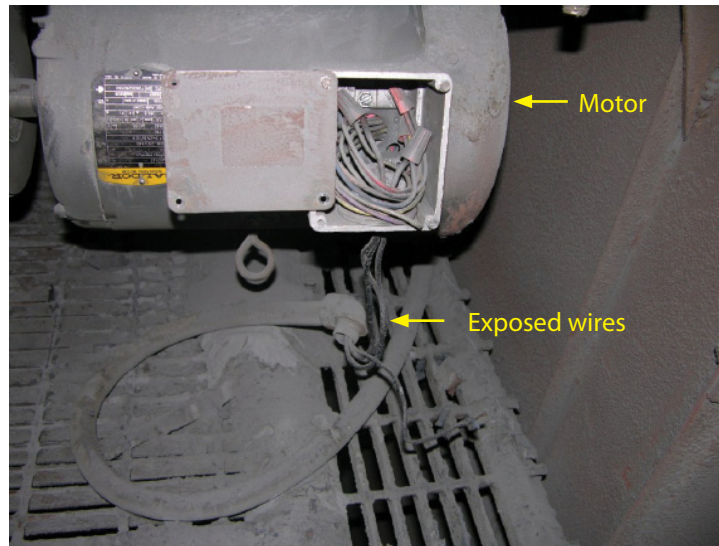
FIGURE 15

Exposed electrical wiring on elevator motor near January 2011 incident site (motor panel cover was rotated post incident by fire department).

The testing contracted by Hoeganaes in 2010 determined that the minimum ignition energy for representative iron dust samples was greater than 500 mJ, and that a continuous arc would ignite the samples. One witness at ground level reported hearing an “electric sound” at the time of the incident. The motor operating bucket elevator #12 was a likely source of ignition since it had exposed wiring, was not properly grounded, and was within a few feet of the dust cloud source. The wiring was exposed because the electrical conduit supplying power to this motor was not securely connected to the motor’s junction box.

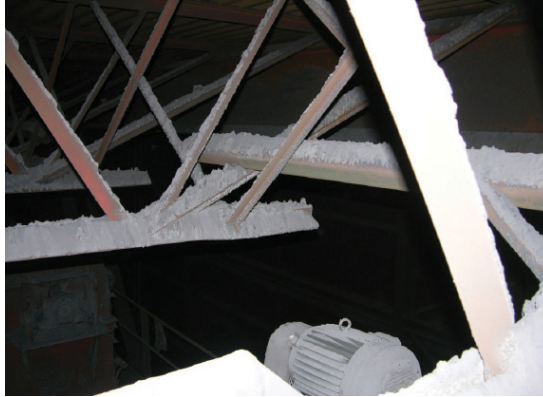
FIGURE 18 (LEFT)

Observations by CSB investigators at the Gallatin facility shortly after the first incident indicated that combustible dust was leaking from equipment and that housekeeping was ineffective (see Figures 16, 18, 19, 20 and 21). Combustible iron dust coated almost every

Iron dust on rafters,
February 3, 2011.

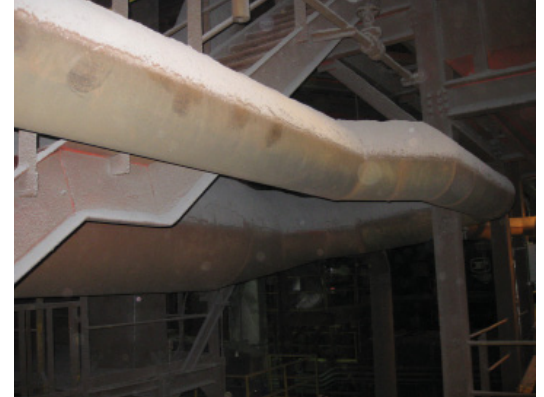
**FIGURE 19 (RIGHT)**

Iron dust on overhead
surfaces, February 3, 2011.

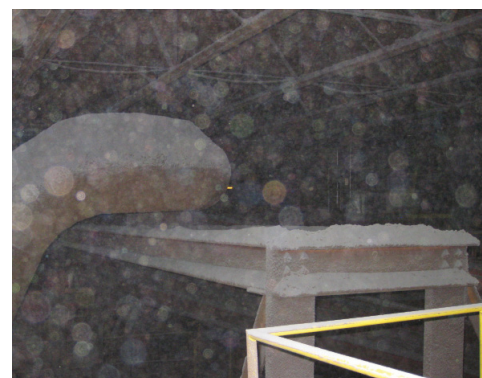
FIGURE 21

Photo of equipment obscured by airborne dust, taken by CSB investigators, February 7, 2011.
