Loss of Containment

A key concept in Process Safety Management is the prevention of loss of containment.

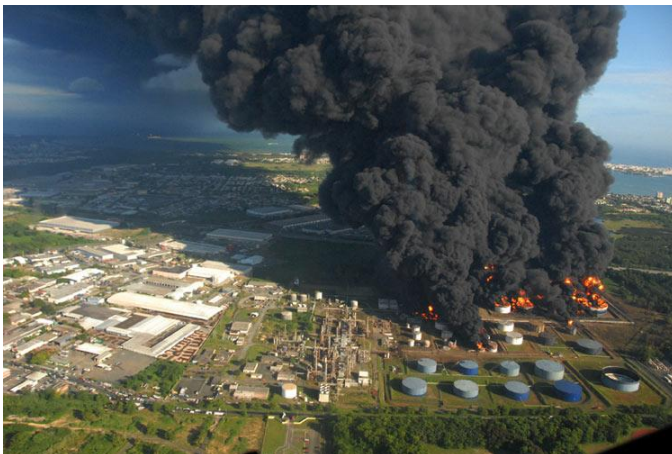
On the night of October 23, 2009, a large explosion occurred at the Caribbean Petroleum Corporation (CAPECO) facility in Bayamón, Puerto Rico, during offloading of gasoline from a tanker ship, the *Cape Bruny*, to the CAPECO tank farm onshore. A 5-million gallon aboveground storage tank (AST) overflowed into a secondary containment dike.

The gasoline spray aerosolized, forming a large vapour cloud, which ignited after reaching an ignition source in the wastewater treatment (WWT) area of the facility. The blast and fire from multiple secondary explosions resulted in significant damage to 17 of the 48 petroleum storage tanks and other equipment onsite and in neighbourhoods and businesses offsite. The fires burned for almost 60 hours. Petroleum products leaked into the soil, nearby wetlands and navigable waterways in the surrounding area.

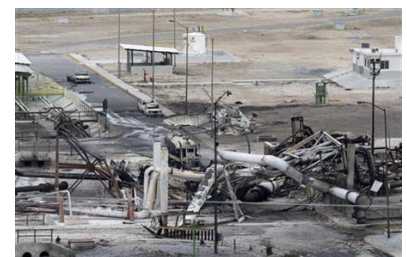
An explosion at a natural-gas distribution plant near the US-Mexico border city of Reynosa in mid-September 2012 killed 30 workers and injured another 46.

The plant measures natural gas extracted from neighbouring wells and transfers the fuel to a nearby processing plant, which separates liquid hydrocarbons from the gas.

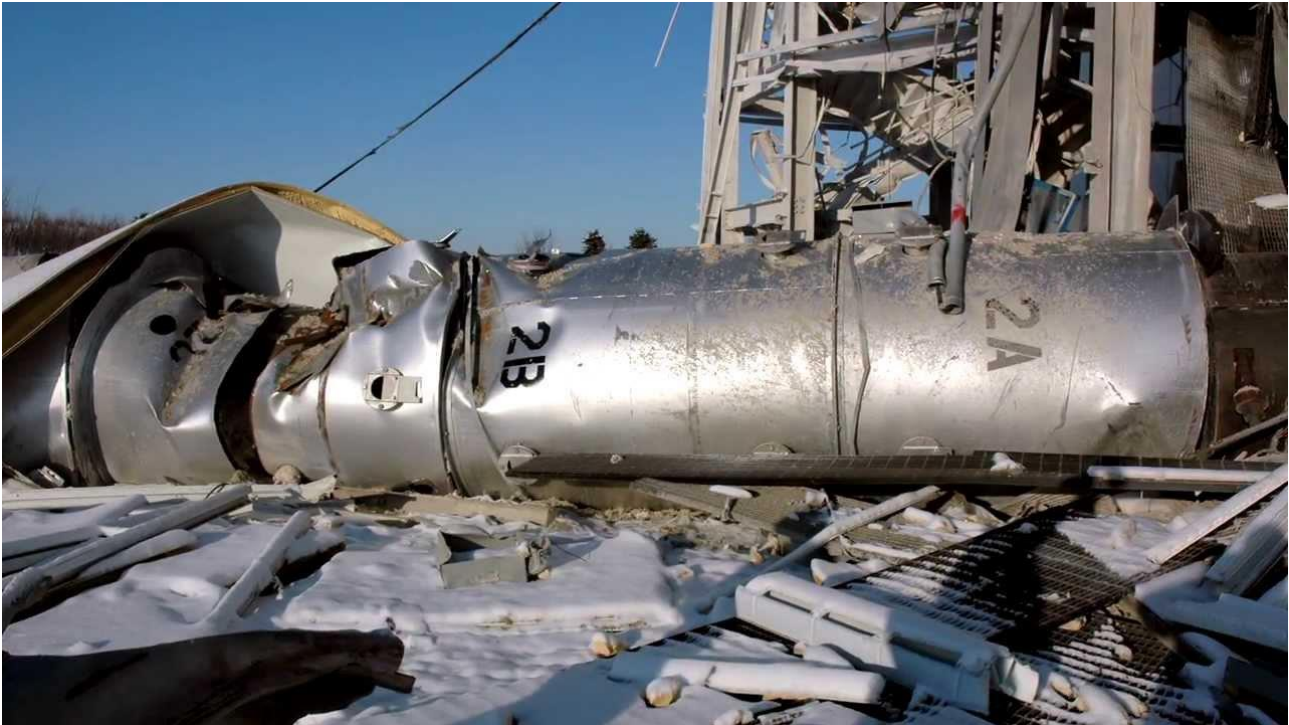
On December 7, 2009, at approximately 2:30 pm, State Special Vessel No. 2, under an operating pressure of 29,000 psig, suddenly and violently ruptured, 120 days into a 150-day operating cycle. A white cloud of steam and debris rapidly expanded outward from the facility, travelled onto the interstate, and dissipated within seconds.

The sudden release of superheated liquid caused an eight-foot tall by four-foot wide vessel fragment, weighing approximately 8,600 pounds, to travel through two concrete walls and finally land about 435 feet from the NDK building. The fragment skipped across a neighbouring facility parking lot and slammed into the wall of an adjacent business office. The force of the impact pushed the wall inward causing furniture to shift and ceiling tiles to fall. One person working near the wall was injured.

The thrust from the escaping liquid caused the base of the vessel to violently shear away from its foundation and blew pieces of structural steel out of the building into the parking lot of a nearby rest stop gas station, known as the Illinois Tollway (I-90) Oasis. One piece of structural steel struck and killed a truck driver at the rest stop. After shearing from its base and throwing shrapnel out of the facility, the vessel swung from the building and landed on the ground outside.
