U.S. Chemical Safety and Hazard Investigation Board

Hoeganaes Corporation: Gallatin, TN Metal Dust Flash Fires and Hydrogen Explosion

January 31, 2011; March 29, 2011; May 27, 2011

No. 2011-4-I-TN

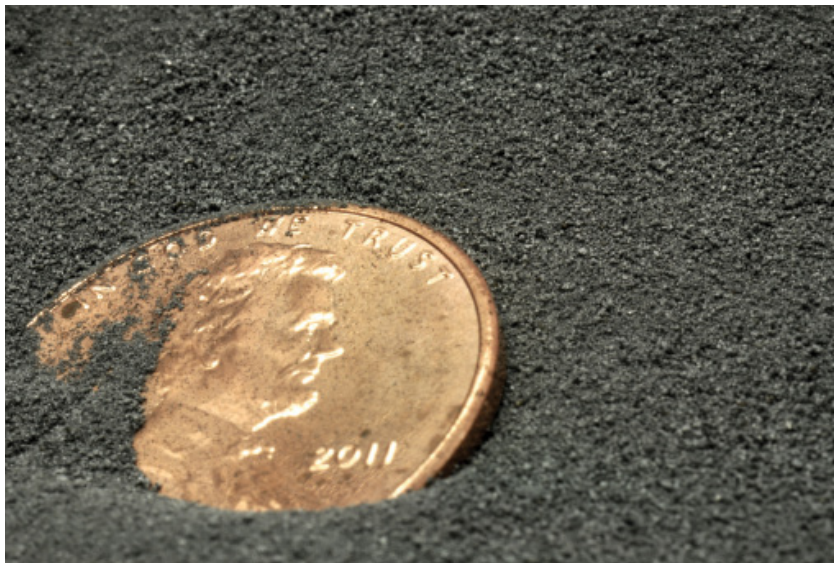
FIGURE 2

In the process of going through the furnace, the coarse powder becomes a thick sheet called “cake.” The cake is sent to a cake breaker and ultimately crushed into the fine PM product. The majority of the finished PM product has a particle diameter between 45-150 microns, or roughly the width of a human hair (Figure 2).

Fine PM collected from the Hoeganaes plant (penny shown for scale).

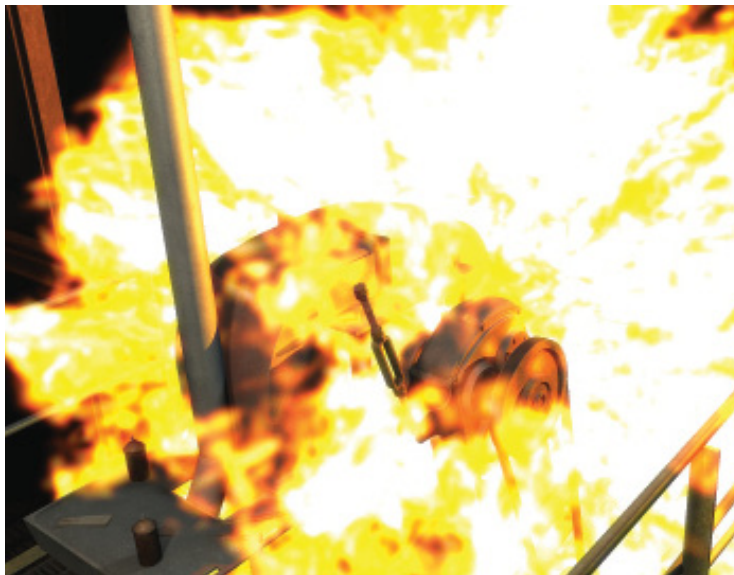
FIGURE 5

Computer graphic of January 31 iron dust flash fire.

City of Gallatin emergency responders arrived with ambulances and transported the mechanic and electrician to the Vanderbilt Burn Center in Nashville, TN. Both employees were severely burned over a large percentage of their bodies. The first employee died from his injuries two days later. The second employee survived for nearly four months before succumbing to his injuries in late May 2011.

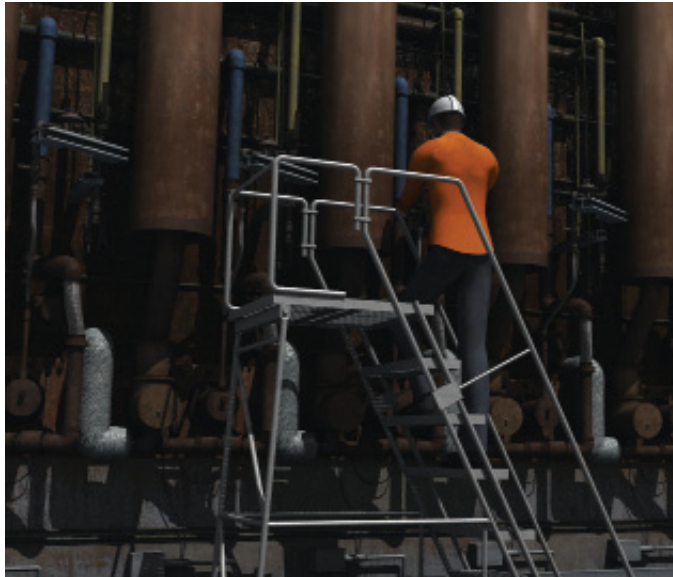
FIGURE 6 (LEFT)

Computer graphic of the gas line connection involved in the March 29 flash fire.

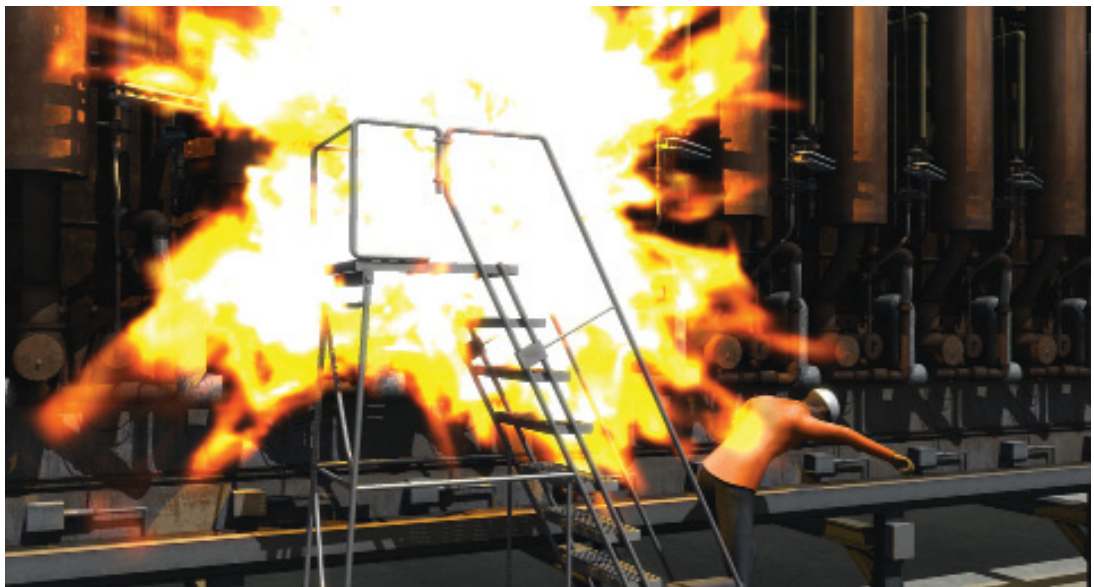
**FIGURE 8**

Computer graphic of March 29 iron dust flash fire.

The engineer was wearing the Hoeganaes-designated personal protective equipment, which included pants and a shirt that were rated as flame resistant clothing (FRC). He was also wearing an FRC rated jacket that provided extra shielding to his upper torso from the flash fire.

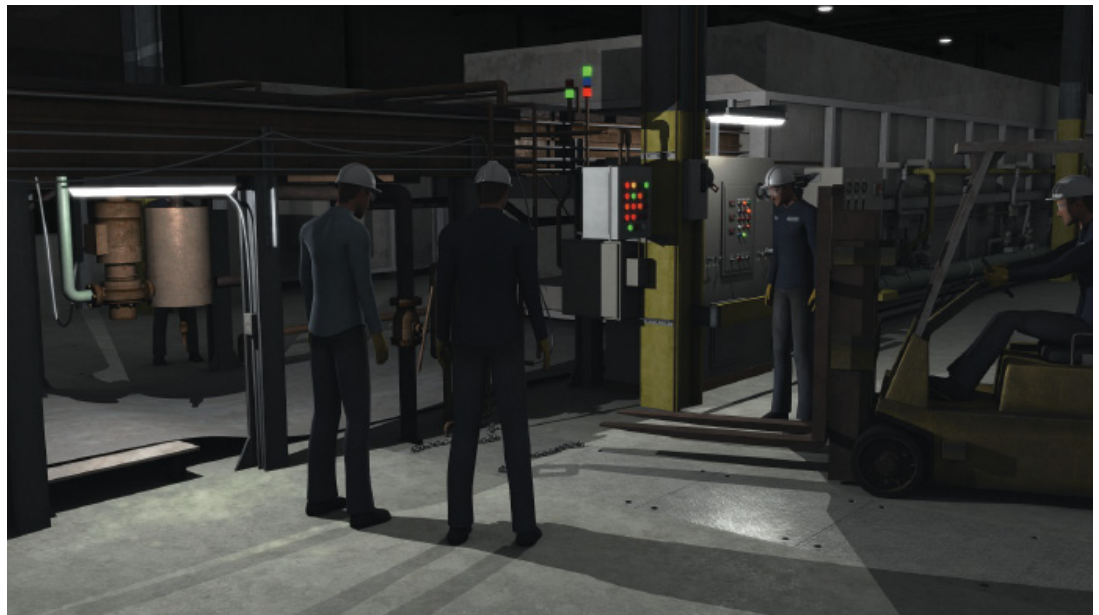
FIGURE 10 (RIGHT)

Computer graphic of maintenance crews starting to remove the trench covers using a forklift just prior to May 27 explosion.

Interviews with eyewitnesses indicate that just as the first trench cover was wrenched from its position by the forklift, friction created sparks, followed by a powerful explosion. Several days after the explosion, CSB investigators observed a large hole (approximately 3 x 7 inches) in a corroded section of piping that carried hydrogen and ran through the trench (Figure 11).

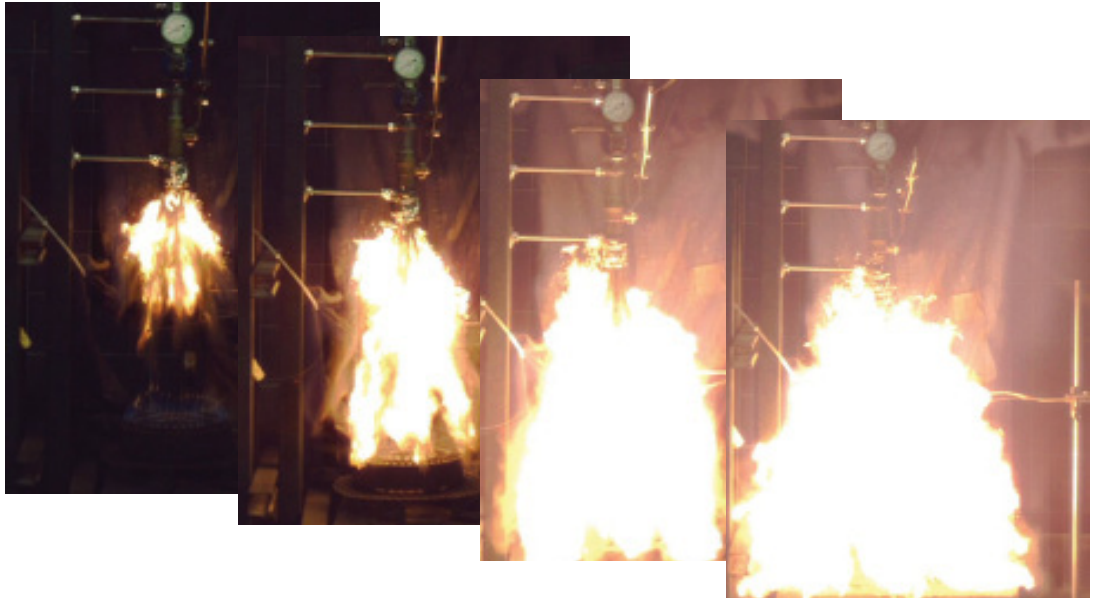
FIGURE 14

This test dispersed about 30 grams of iron dust—sampled from the baghouse⁹ associated with the bucket elevator from the January 31, 2011, incident—above an 8 inch burner. Upon being released, the dust auto-ignites in air due to the heat given off from the burner below (Figure 14). An intense white flame was produced that reached a peak diameter of 18 inches.

CSB iron dust combustibility demonstration, see Section 4.1.1.1.
